# HOT-STOP® XLN Field Performance Report

Industrial Energy Products, Inc.  
56 Newcomer Road  
Mount Joy, PA 17552  
www.iepindustrial.com

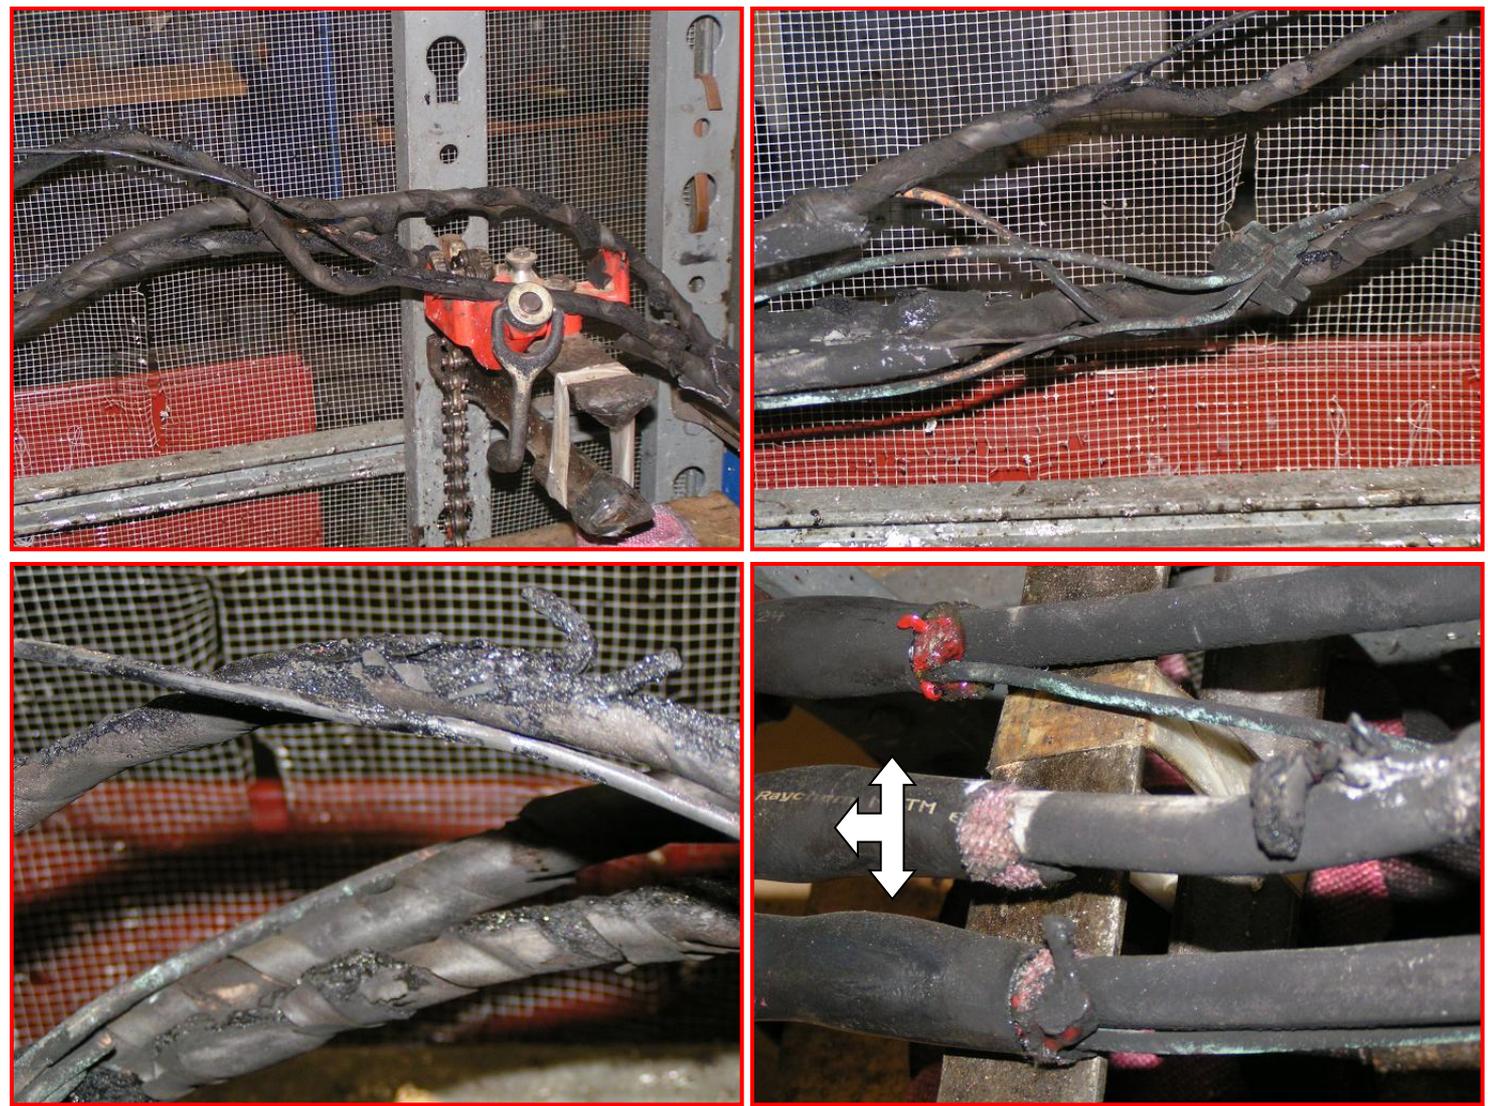
The cables above were taken from a PECO Energy vault that experience an arc fault on a 120 240 cable. The arc ignited a 13,000V cable that was in within 6" of the arc. The vault eventually became fully involved in fire, the section of cable that was protected with **HOT-STOP® XLN-3-RR** were found to be in excellent condition. The arrow above highlights the end on the **HOT-STOP® XLN** installation.

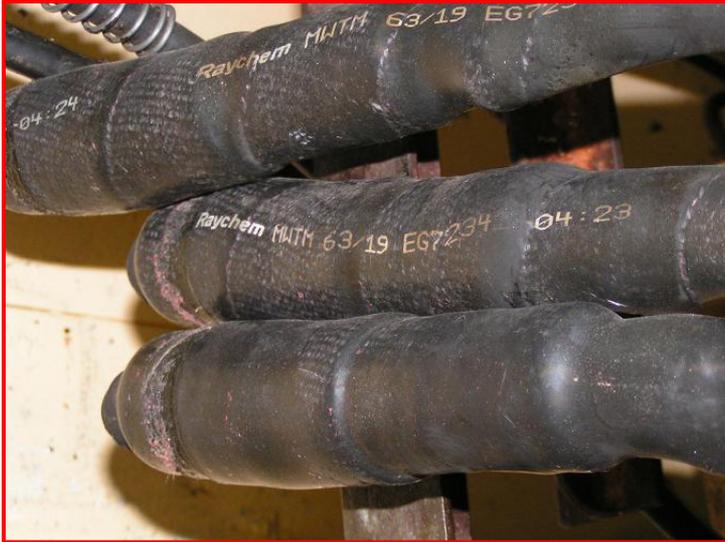
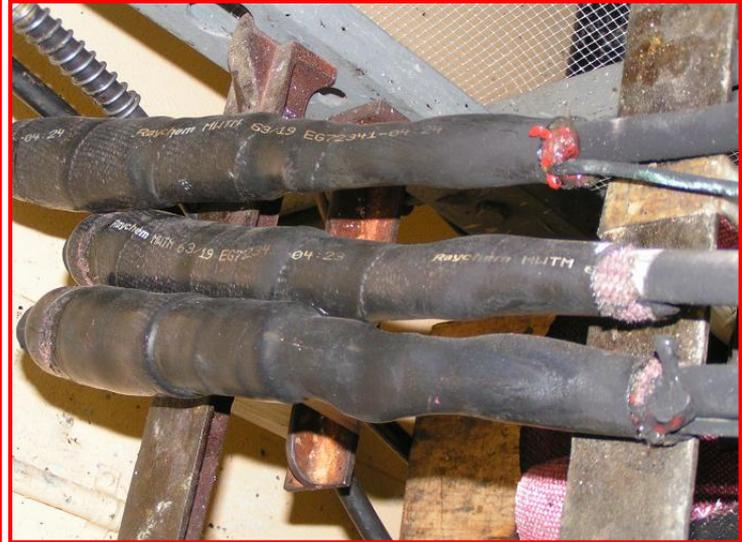
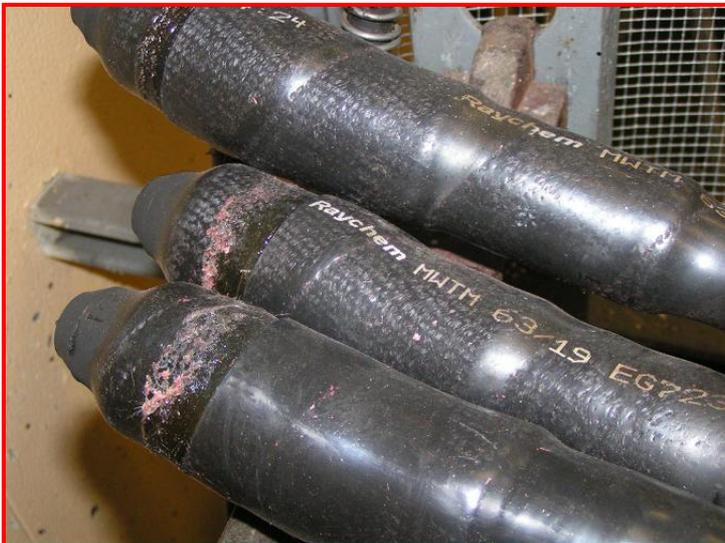
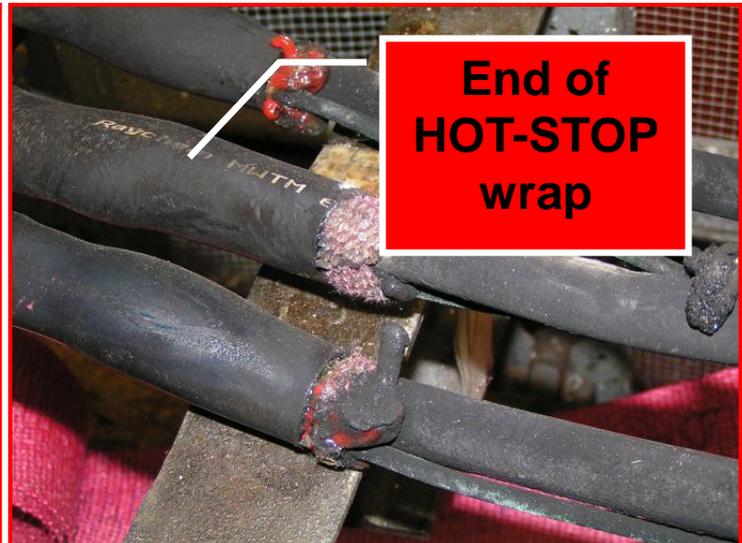
Sections of cable protected with HOT-STOP® XLN-3-RR.

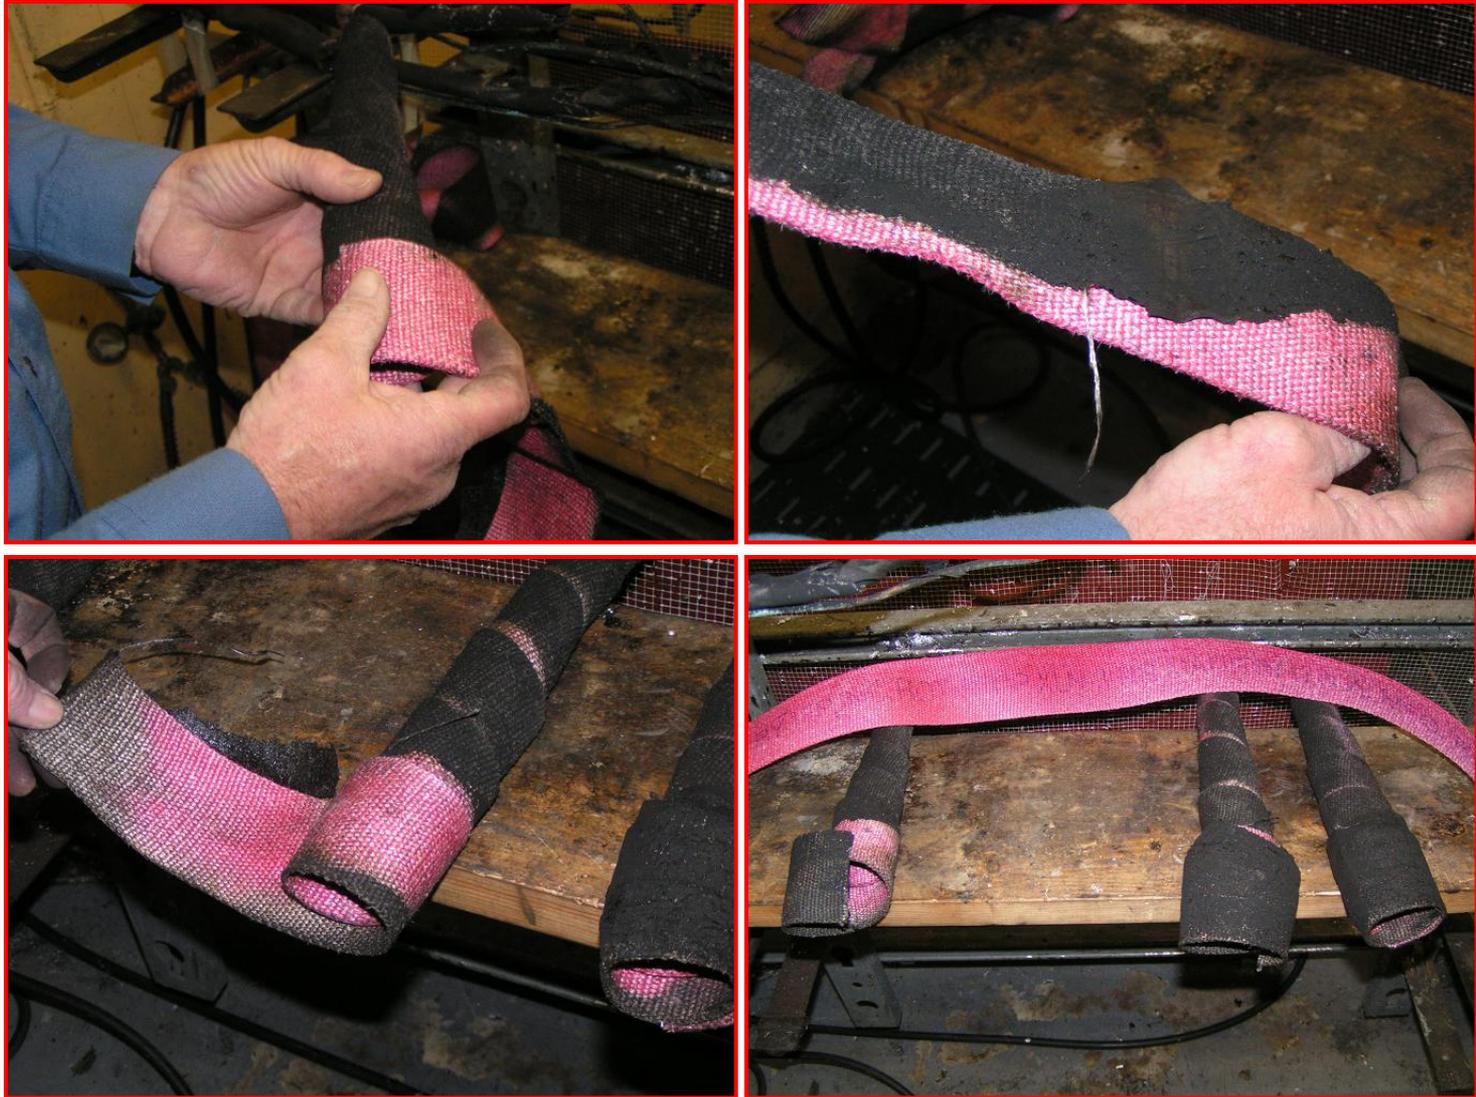
Above are retained samples of the **HOT-STOP® XLN-3-RR** that was applied to cable. The clear color line outlined by the products of combustion deposited on the surface of the tape during the underground incident are evident on the surface of the retained length of tape. *Performance, protection and results.*
